STREAM AND FLOODPLAIN RESTORATION

_____ IN GLEN CREEK,

DENALI NATIONAL PARK AND PRESERVE

Technical Report NPS/NRWRD/NRTR-94/17

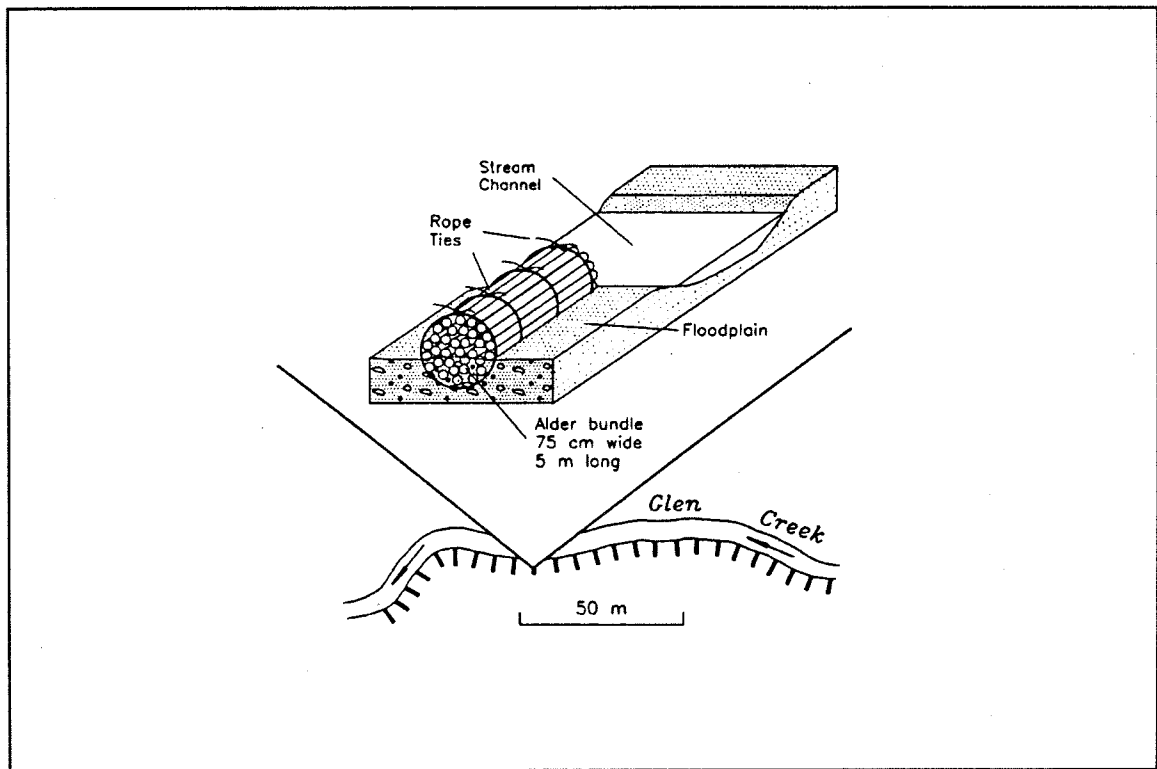
Figure 4. Brush bar pattern, with one channel-width spacing along left bank of new channel reach in lower study area. Inset shows typical installation of alder bundle, adjacent to channel, and anchored to the floodplain.

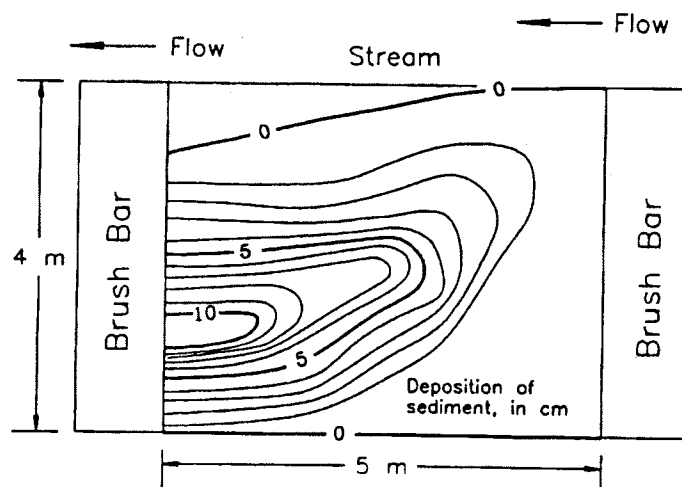
Floodwater cut behind only the first few brush bars in each group on the lower reach, where the bars were only one stream width apart. Substantial amounts of sediment were deposited on the floodplain where water did not run behind the bars. Cross-section 1 in Reach 4 (Appendix A) shows substantial deposition on the left bank (where the bars were located). Figure 11 depicts the average deposition of material adjacent to brush bars installed along the new channel section.

Figure 11. Typical sediment deposition depths, in centimeters, for brush bars spaced one channel-width apart, along new channel reach.

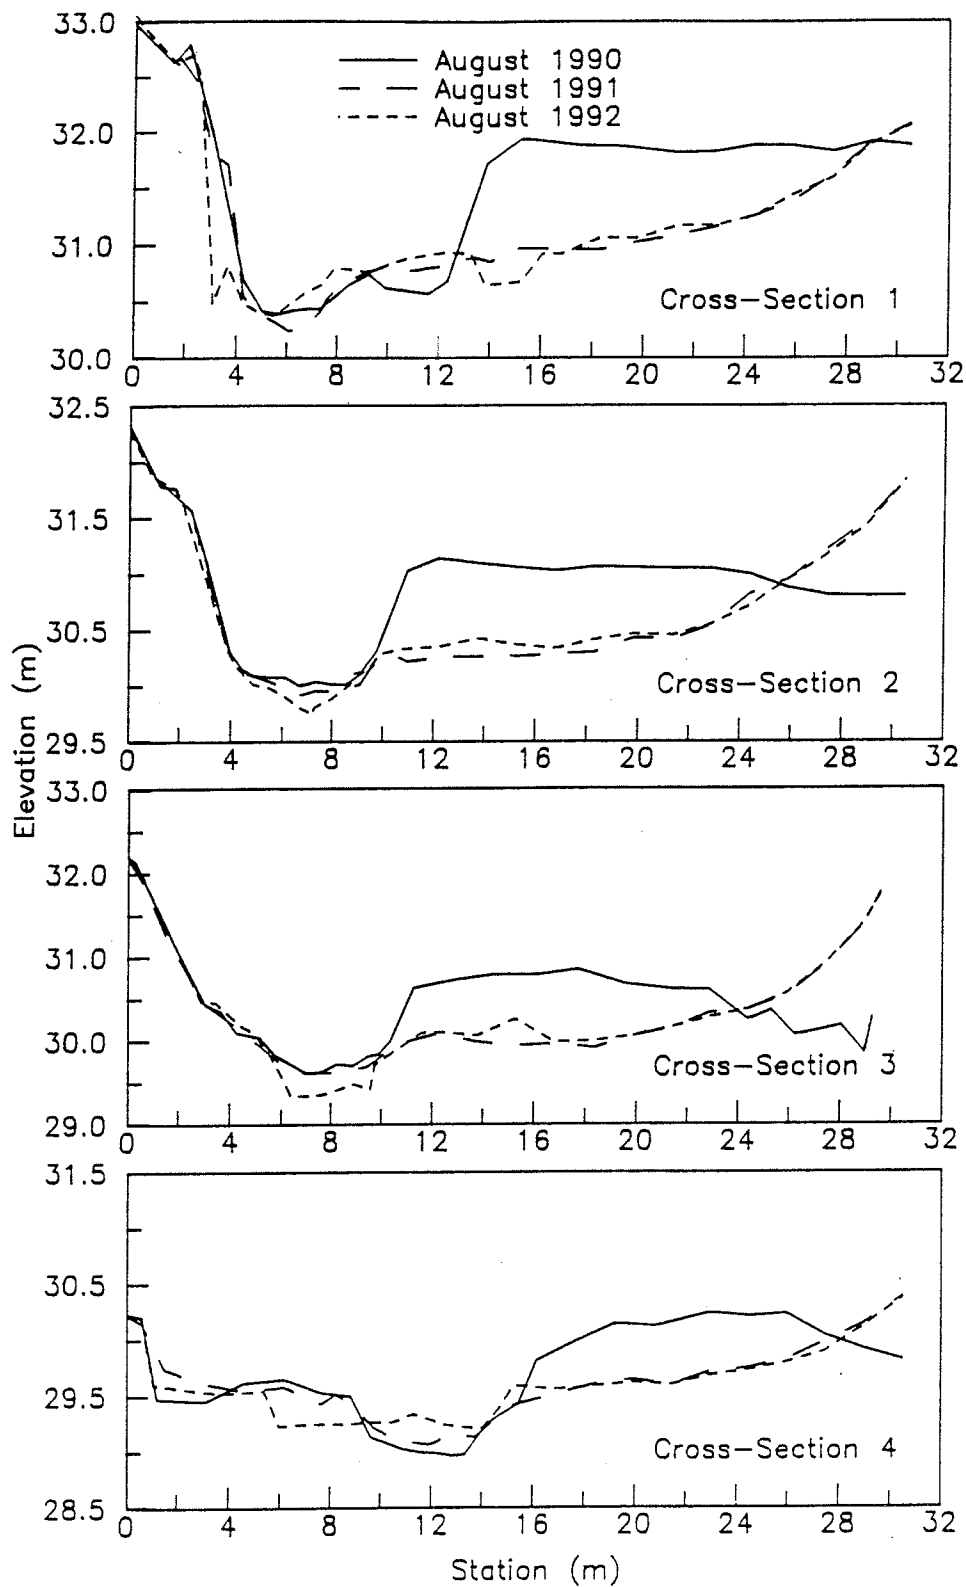
Cross-section 1-4 in Reach 3 also shows channel changes in the upper study area, which suffered bed and bank erosion and channel widening.

Figure 14. Cross-sections for Reach No. 3. These cross-sections are located in the Upper Study Area, which was restored in July 1991.

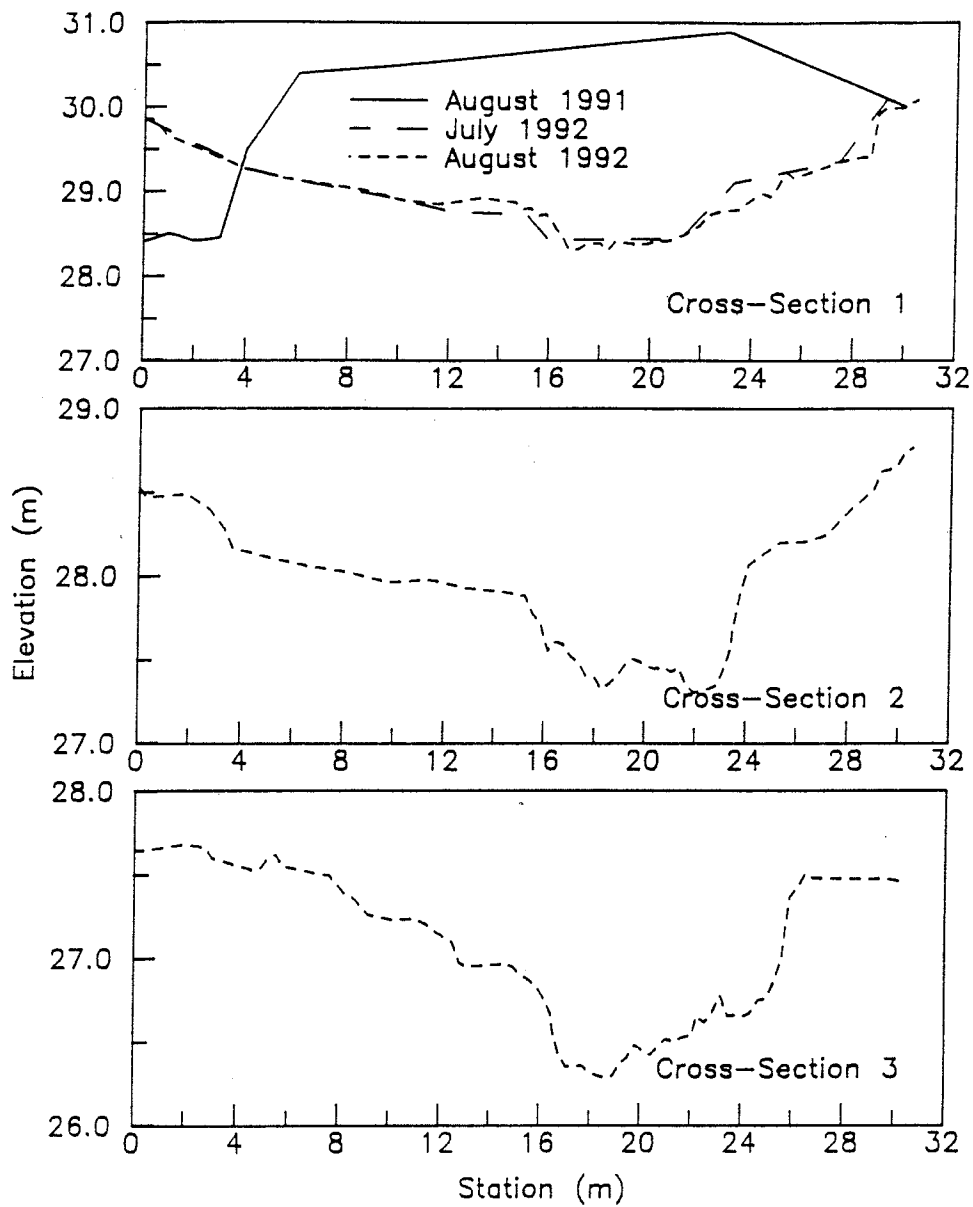
The passage of the August 5, 1992 flood event caused several significant changes to the channels in these areas. Severe bank erosion, channel widening, and lateral migration of the channel were noted in both study areas. In the lower area along the new channel segment, enough erosion and lateral movement of this reach occurred, to result in a slope decrease of almost 5 percent, with a corresponding increase in channel sinuosity. The erosion took place along the right bank, which was unprotected by alder brush bars. See Cross-section 1 in Reach 4 (Appendix A).

Figure 15. Cross-sections for Reach No. 4. These cross-sections are located in the Lower Study Area, which was restored in July 1992. Cross-section 1 was established in 1991. Cross-sections 2 and 3 were established after construction in 1992.
